# Manhole Inspection Summary

Manhole # S35SS1016MH

Insp Date: **2/28/07 10:10 AM**

**Location** Address: **421 TANTALLION CT**

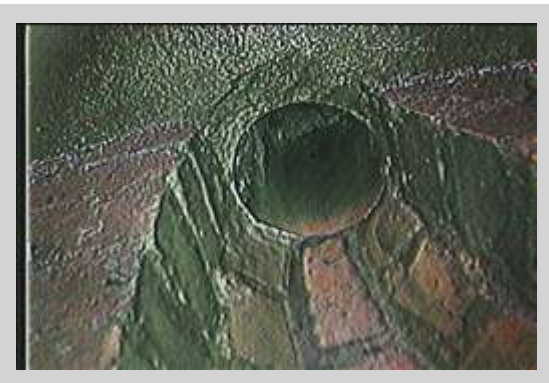
### 6 in. Circular Gravity Sewer Pipe In @ 9 O'Clock

Rod and Bar (Angled)

Pipe Material: **Clay** ☐ Pipe Lined

Infiltration: **None** Pipe Seal Cond: **Unknown**
